# Manhole Inspection Summary

Manhole # S23K\_\_053MH

Insp Date: **1/9/09 12:32 PM**

**Location** Address: **228 KUPER-MCHENRY**

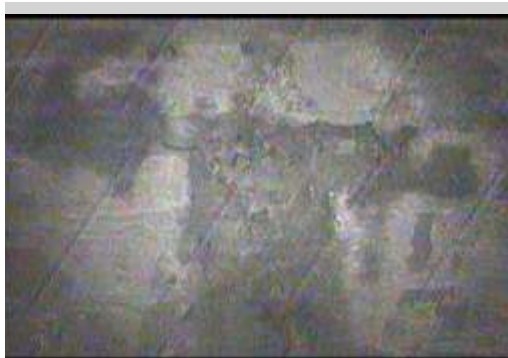
Defect 3

Infiltration: ☐ None ☐ Joint ☐ Cracks ☐ Mortar ☐ Roots ☒ **Wall**

INFILTRATION @ BARREL WALL

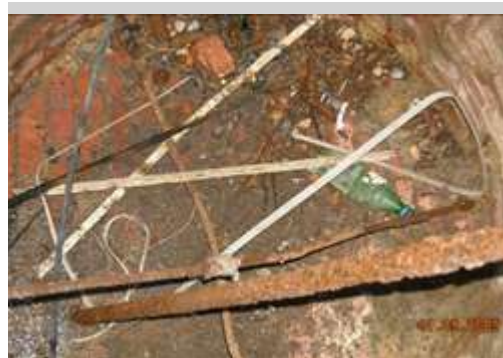
Defect 2

Condition: ☐ Sound ☐ Cracked ☐ Root Intrusion ☐ Deteriorated ☐ Leaks ☒ **Debris**

DEBRIS IN TERMINAL CHANNEL

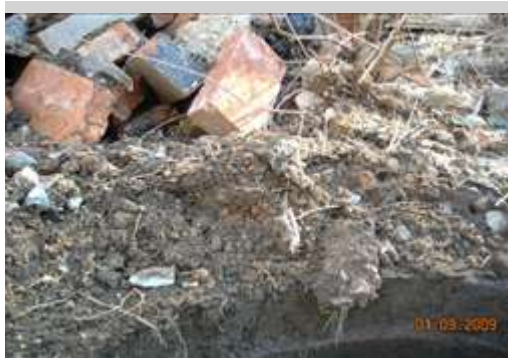
### Defect 1

**Cover** Shape: **Circular** Diameter: **24** (in.) Length: **0** (in.) Dist A/B Grade: **-2** (in.)

FRAME BELOW GRADE

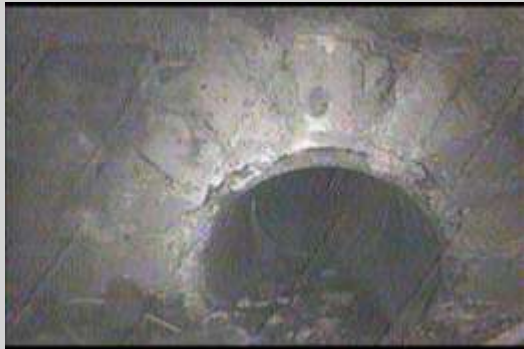
12 O'Clock Outflow

8 in. Circular Gravity Sewer  
Pipe Out @ 12 O'Clock

Infiltration: **None** Pipe Seal Cond: **Sound**
